APPENDIX B: NASA Analysis*

KSC-MSL-0741-1998

SUBJECT: Analysis of the Excess Flow Control Valves and Metallurgical Studies of a Propane Storage Tank Involved in the Boiling Liquid Expanding Vapor Explosion (BLEVE) near Albert City, Iowa.

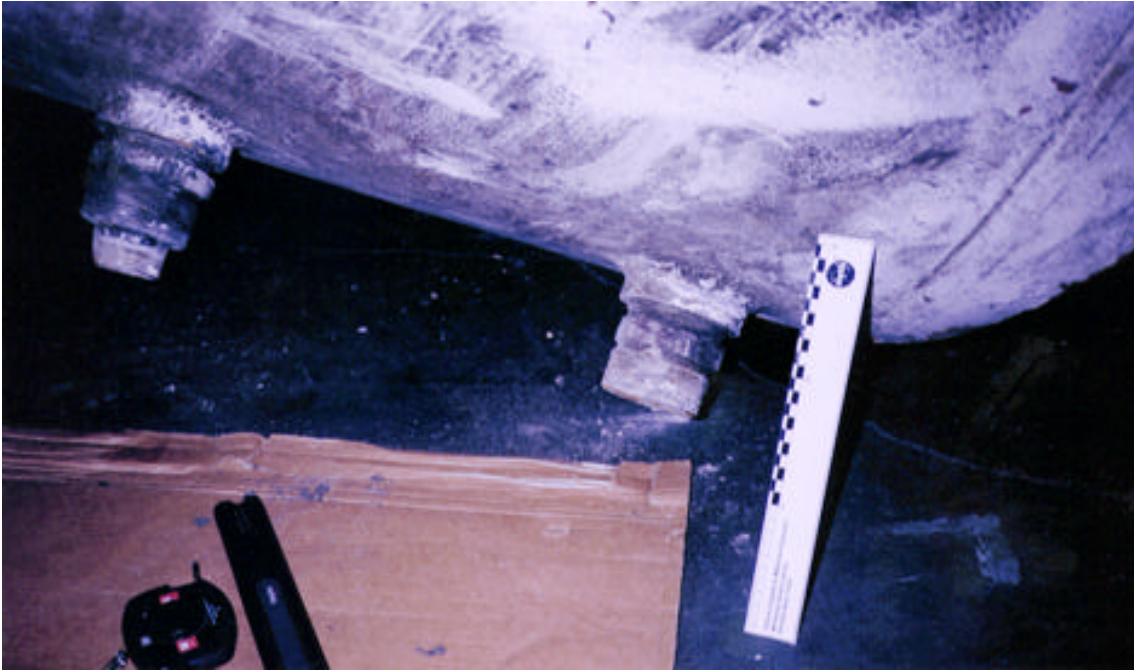
FIGURE 1

The two liquid excess flow control valves in the tank section prior to removal for testing purposes.

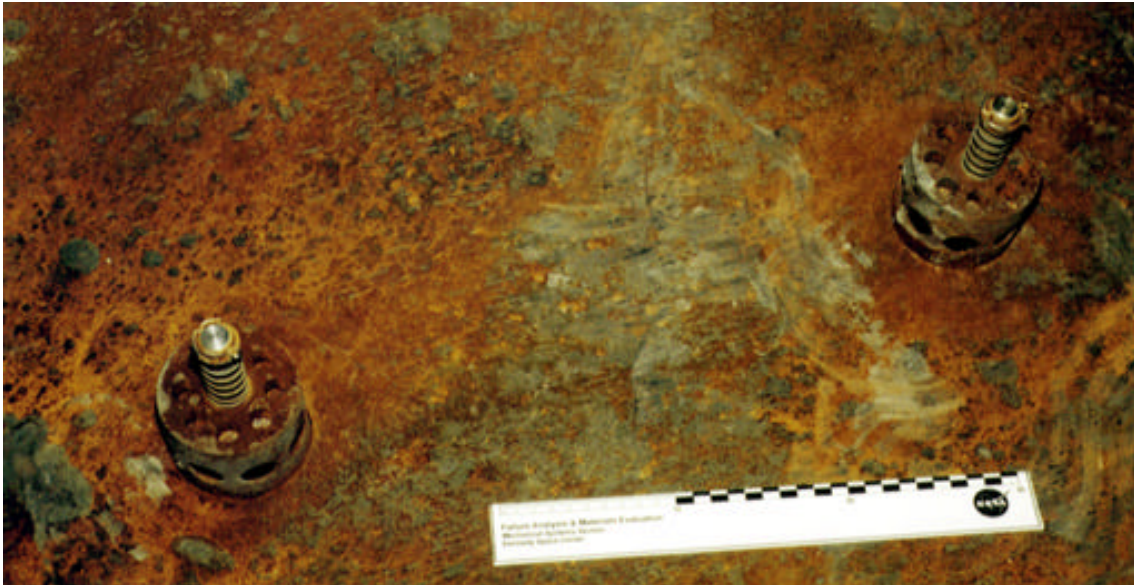
FIGURE 2

The two liquid excess flow control valves as seen from the interior side of the tank section.

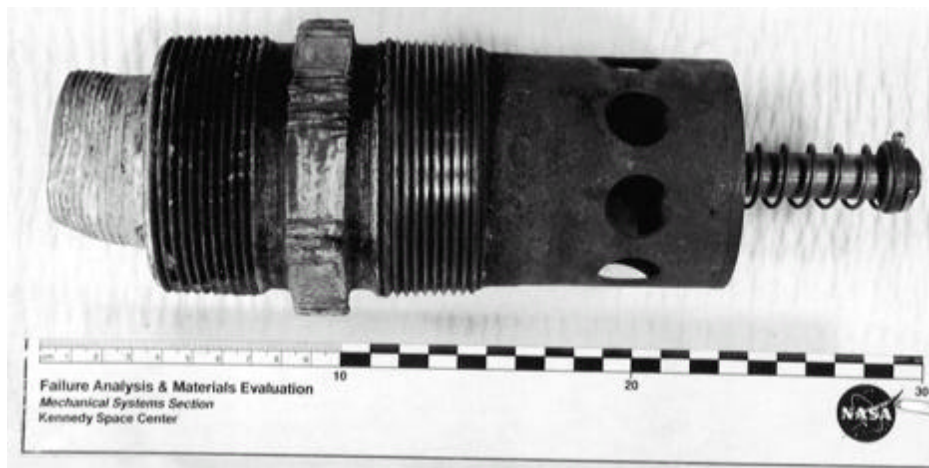
FIGURE 5

Liquid flow control valve FV3 as-received in the laboratory.

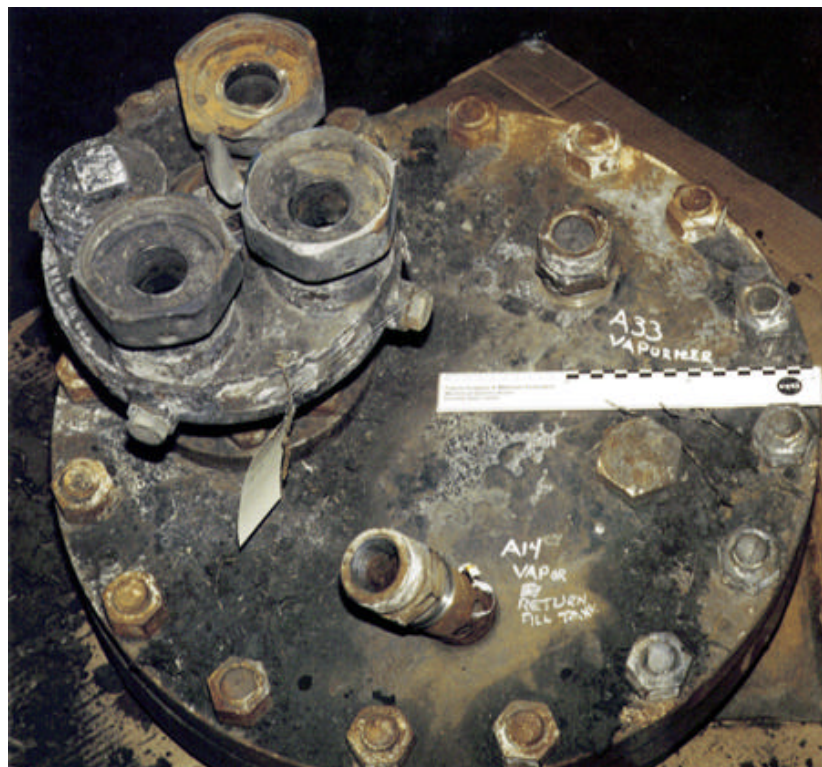
FIGURE 6

- 2.8 The three pressure relief valves remaining in the man-way cover were only valve bodies. The internal components are thought to have been expelled prior to the propane tank explosion, probably due to excessive pressures inside the tank. These valves were not removed or tested, as they are not functional in their current condition. It was reported that the pressure relief valves were set to open at 250 psi pressure.

Propane tank man-way cover as seen in the Des Moines, Iowa storage warehouse. Vapor excess flow control valves are labeled A14 and A33. Three pressure relief body shells can be seen on the elevated connection plate.

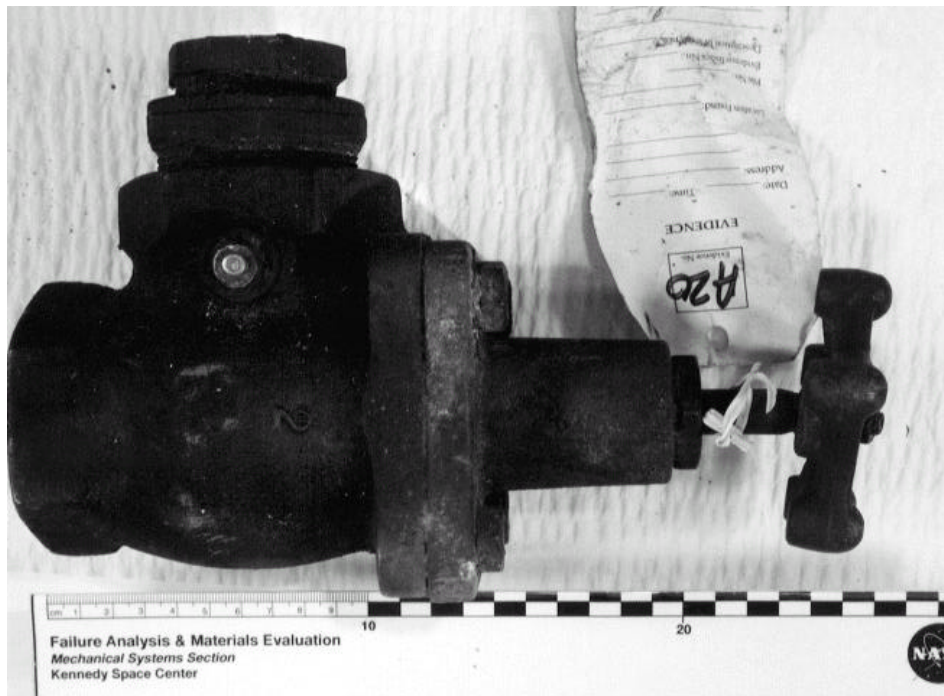
FIGURE 10

The lower view is the hand valve A20 as-received in the laboratory.

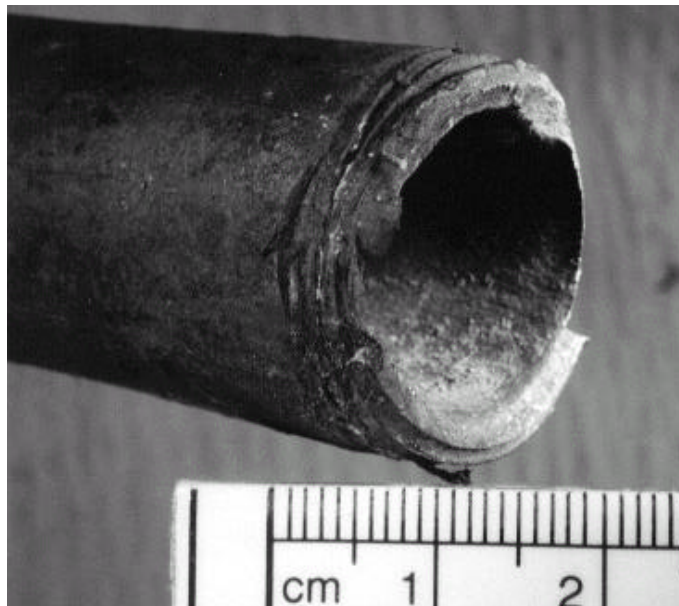
FIGURE 11

- 4.2 The vaporizer pipe appeared to have been broken mechanically from the reducer bushing in hand valve A20. Due to the constraint of not being able to dissect the pipe in the laboratory, further analysis was not possible. The corrosion on the fracture of the pipe was post-fracture and not a contributing factor.

Fracture surface of the one inch pipe that previously connected to hand valve A20.

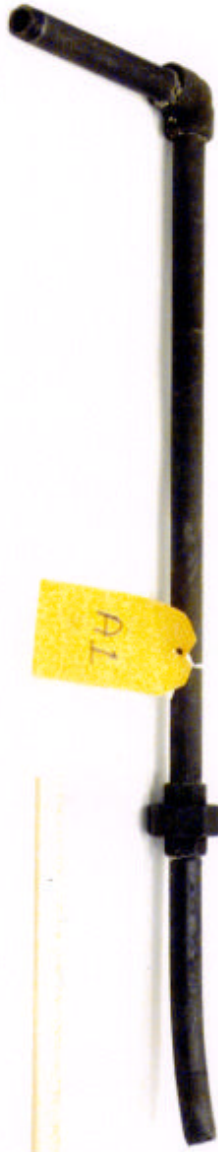
FIGURE 29

View of the pipe that fed liquid propane to the vaporizer units.

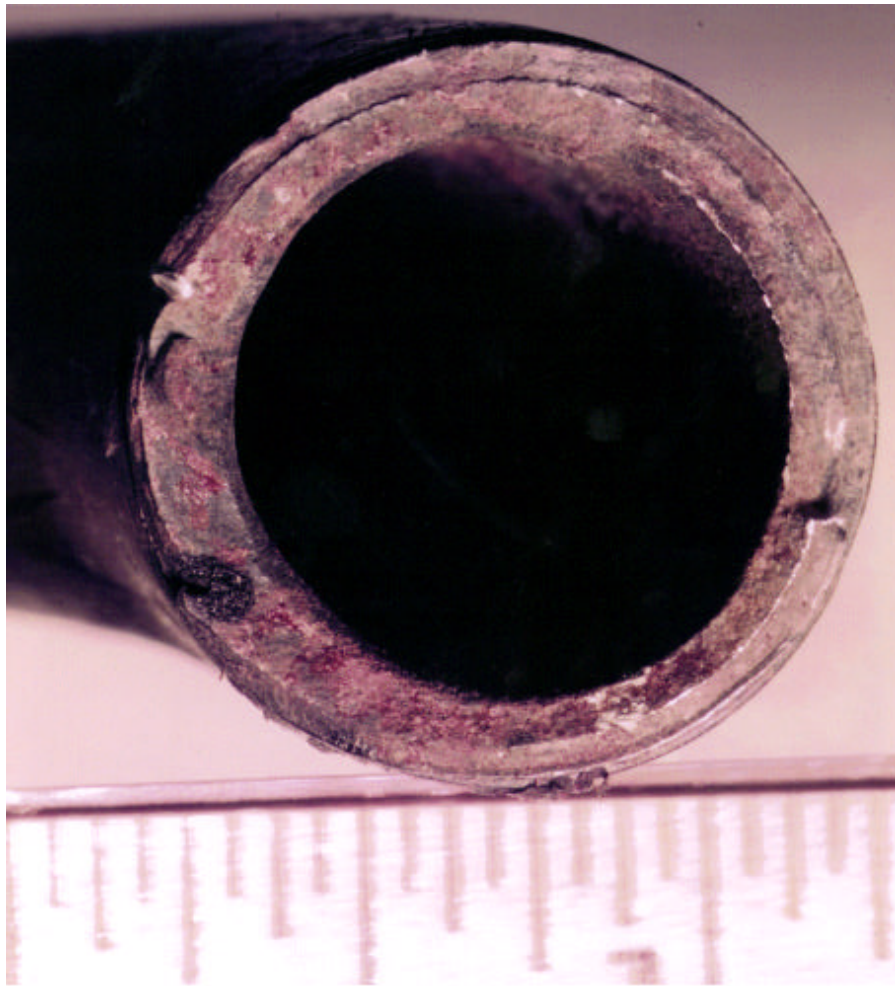
Figure 37
View of the fracture surface of the one inch pipe (A1) which carried liquid propane to the vaporizer unit

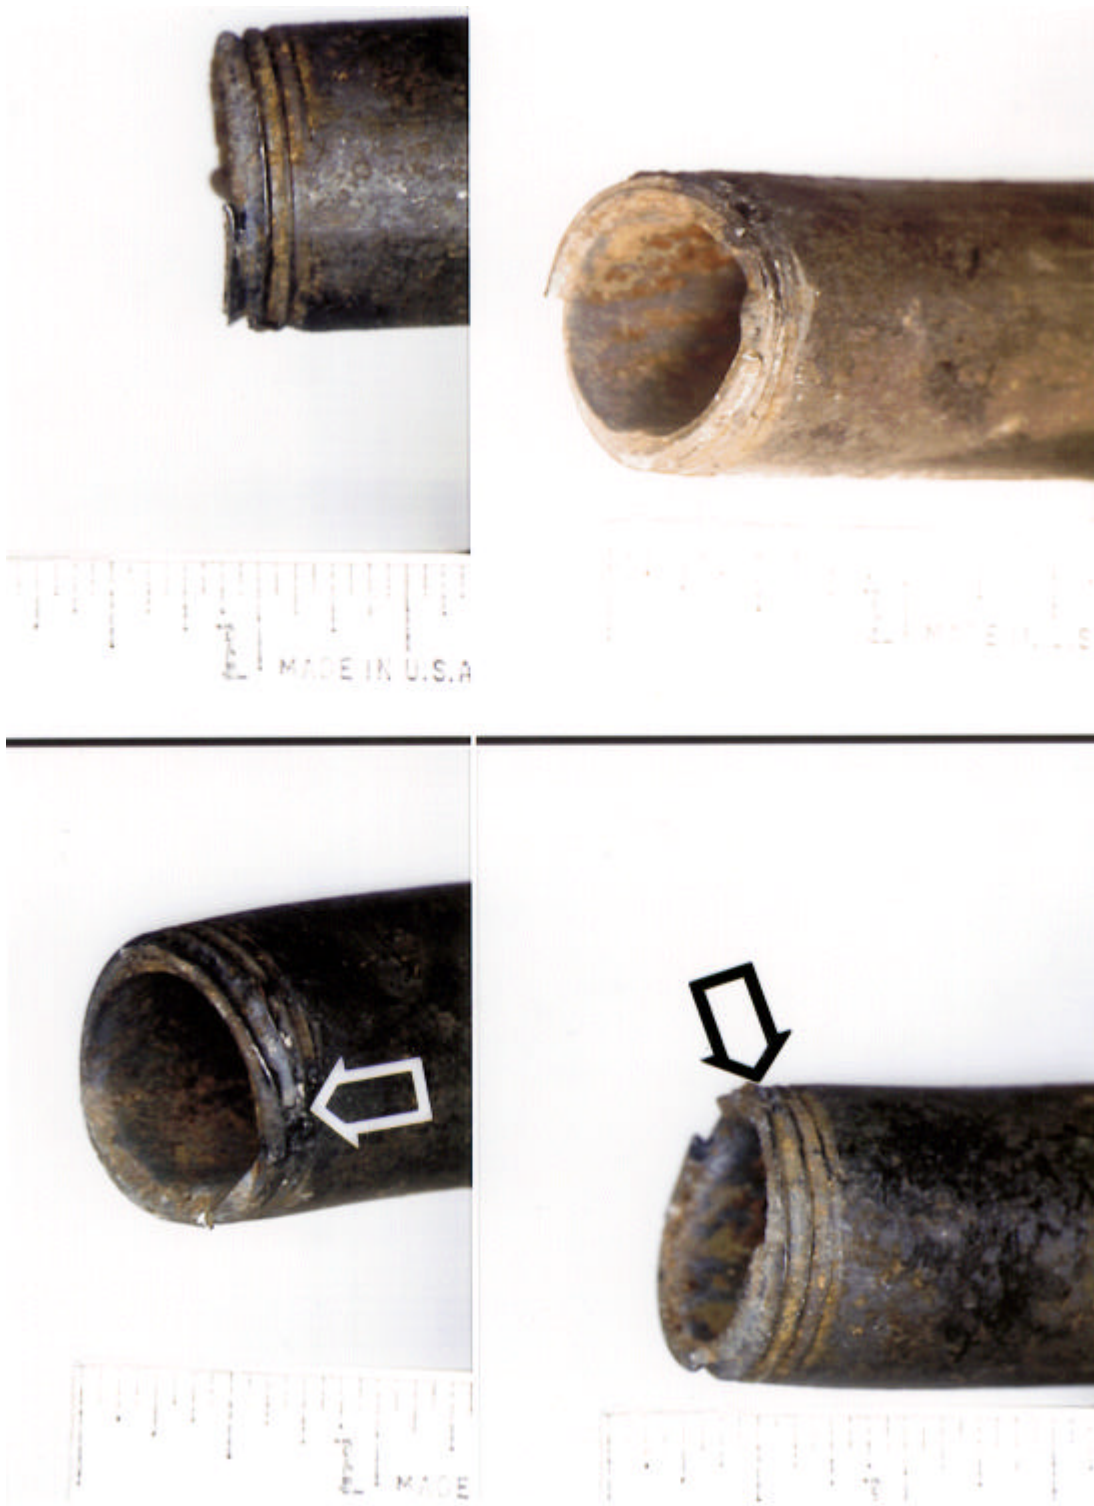
Figure 38

- 3.2 The section of the tank shell that exhibited necking (Figure 26), the section that appeared unaffected by the heat (Figure 27), the tank head section (Figure 28), and the vaporizer pipe (Figure 29) underwent stereo- and macroscopic examination at KSC. The fracture surface in the necked-down region appeared corroded and smeared (Figure 30). Likewise, the section that was unaffected by the heat appeared corroded (Figure 31) and severely smeared (Figure 32). A comparison of the necked region with the unaffected region revealed the substantial ductility of the area that had been affected by the heat, i.e., the necked region (Figure 33). The lamellar region (Figures 34 and 35) appeared slightly corroded with minimal post-fracture damage. The end of the vaporizer pipe (Figure 36) that mated with the hand valve (A20) appeared rough and slightly corroded (Figure 37). The end of the pipe was bent approximately 25° with respect to the longitudinal axis. The threads of the pipe displayed mechanical damage (Figure 38), with the threads on the concave side of the bend appearing compressed (Figure 39).

90° rotational view of the threaded end of the one inch pipe (A1). Arrow indicate deformed threads.

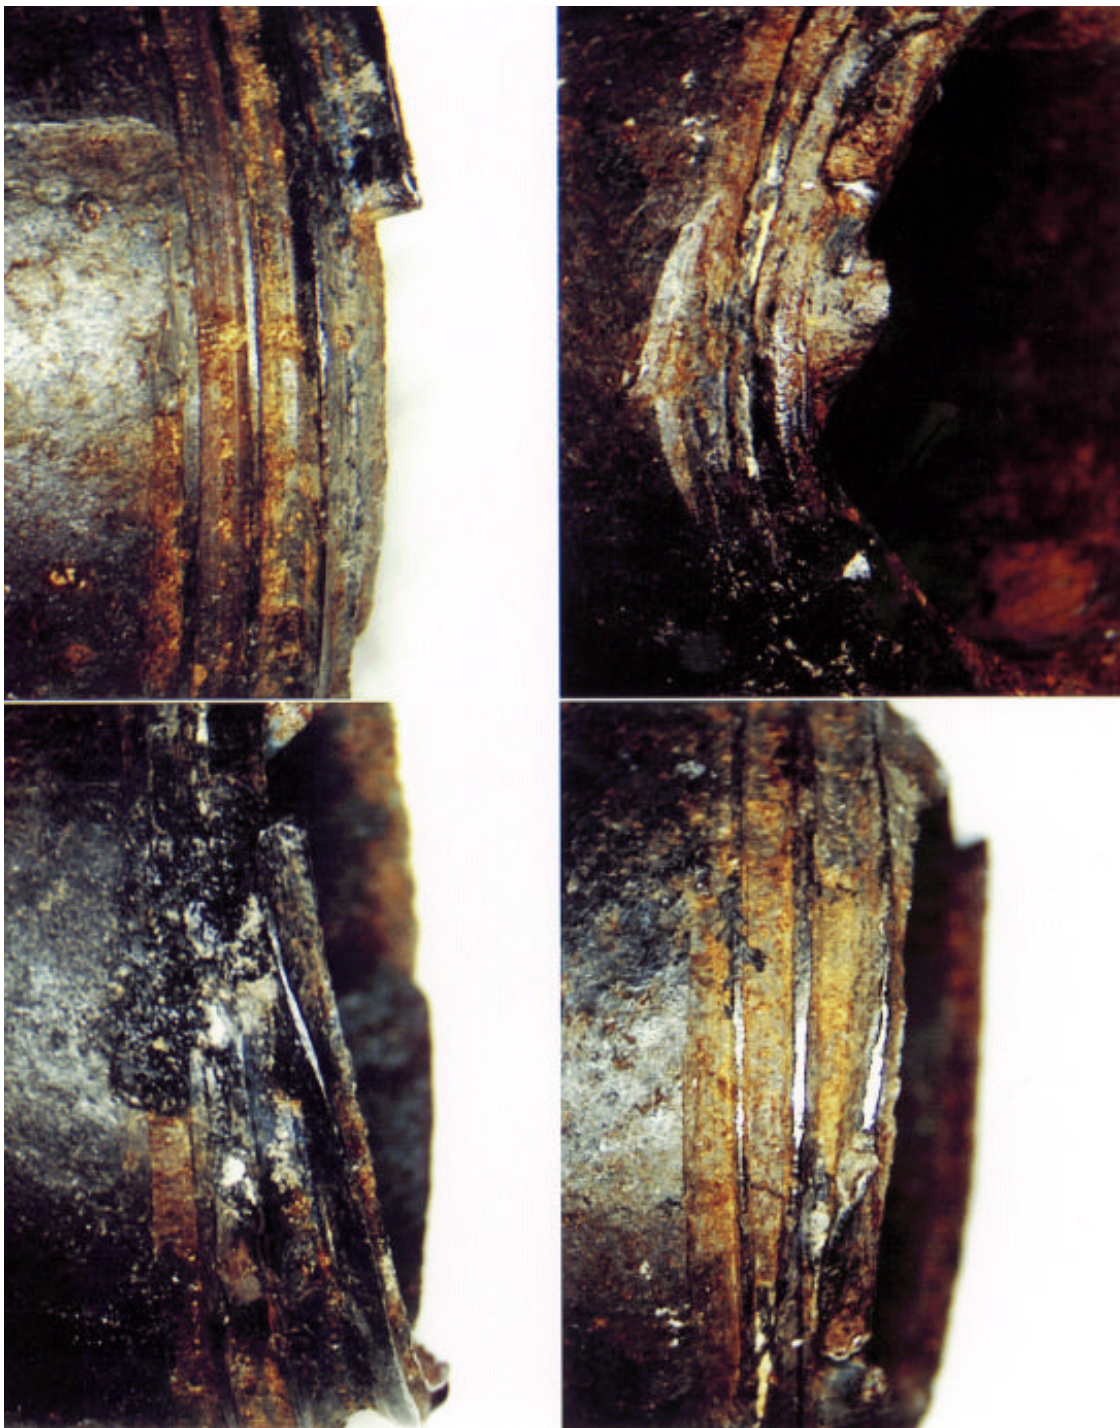
Figure 39
90° rotational view of the condition of the pipe threads on the one inch pipe (A1).
MAGNIFICATION: 5X
